# **WORKSHOP ON BITUMEN EMULSION TECHNOLOGY**

## **Five-Year Field Performance of Cold Recycling in a Cold Climate**

**Jenna Bowers, P.E.**  
**Product development manager**  
**Ingevity**

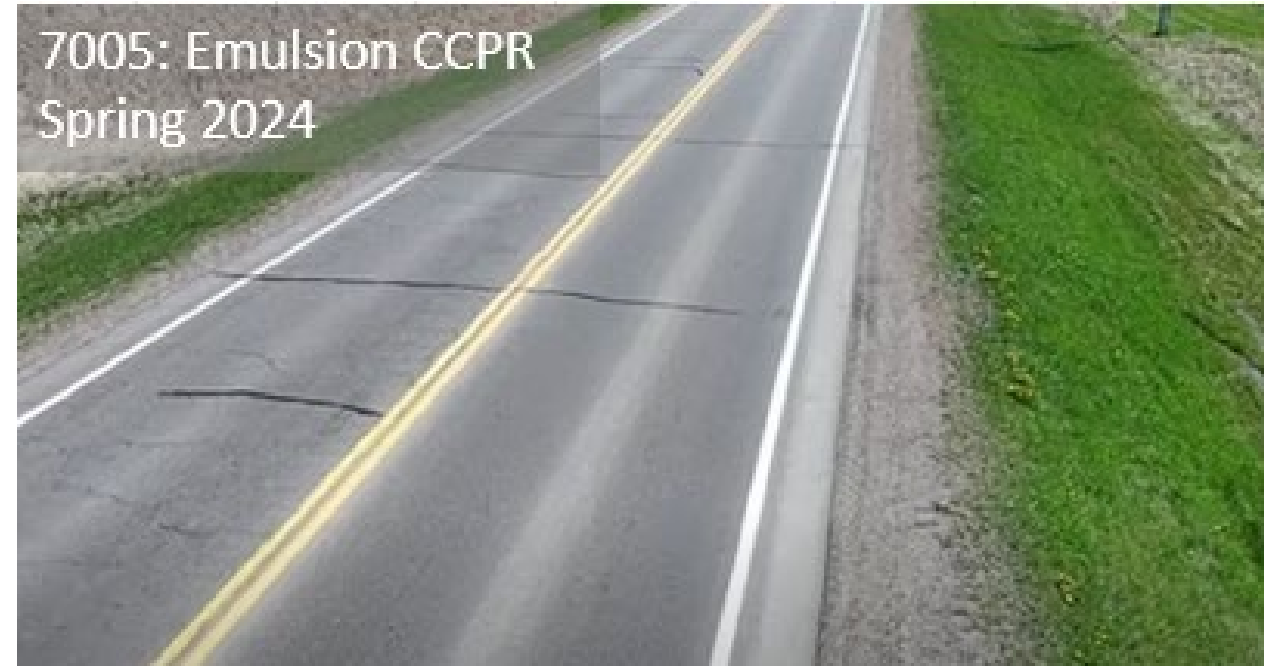
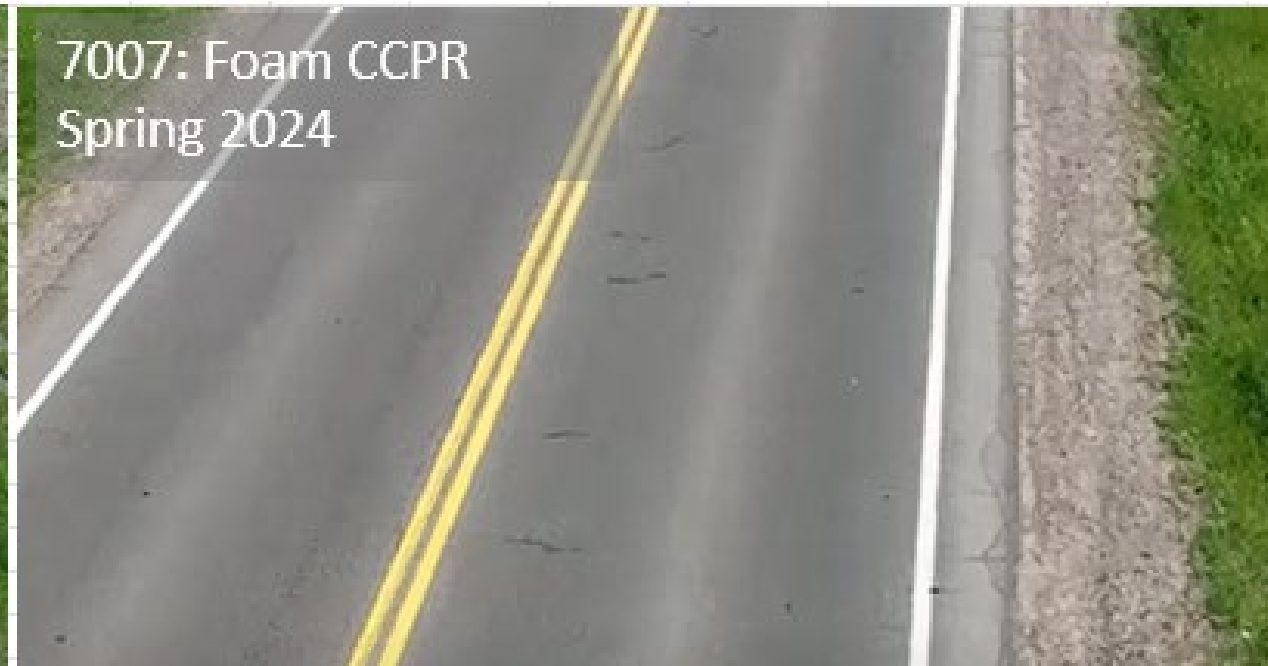
# Pictures of CCPR Sections

The CIR and CCPR sections constructed in the cold region of Minnesota are still performing very well after 5 years.
