# **WORKSHOP ON BITUMEN EMULSION TECHNOLOGY**

**DURABILITY OF EMULSION  
BASED WEARING COURSES**

**Xavier CARBONNEAU**  
**Senior Technical Advisor - COLAS**

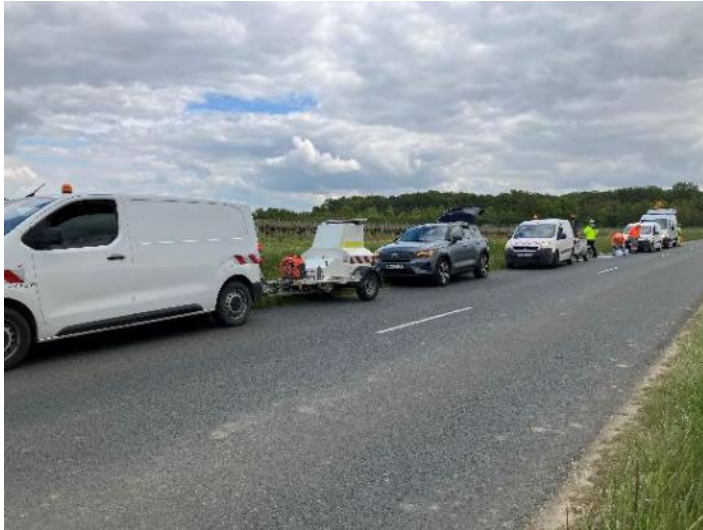
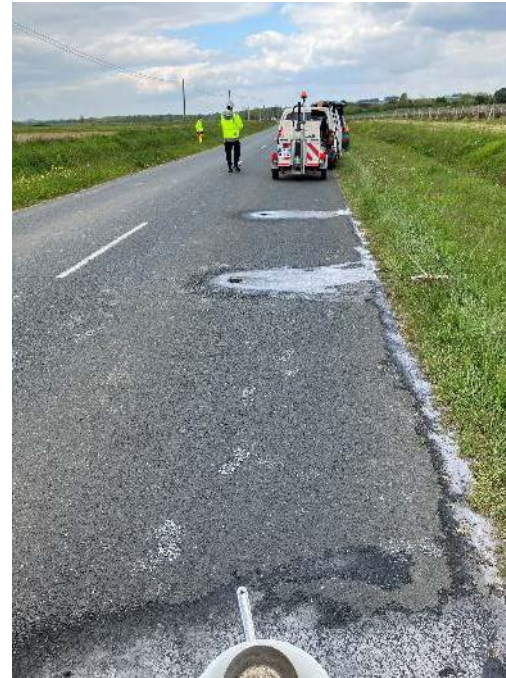
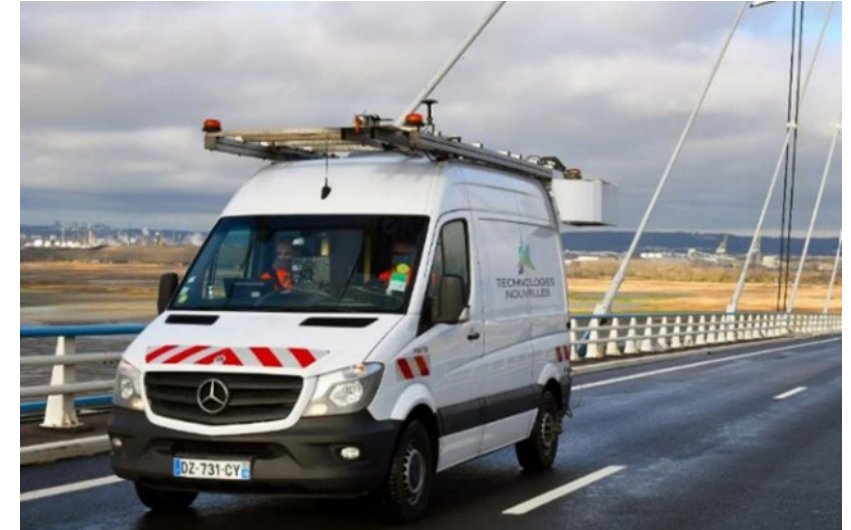
## **CORE SAMPLING – ON SITE MEASUREMENTS**

Coring - FWD -PMT : 25,26 & 30 April + 13&14 May 2024  
Survey (Evalis 3D TN) : 13&14 May 2024

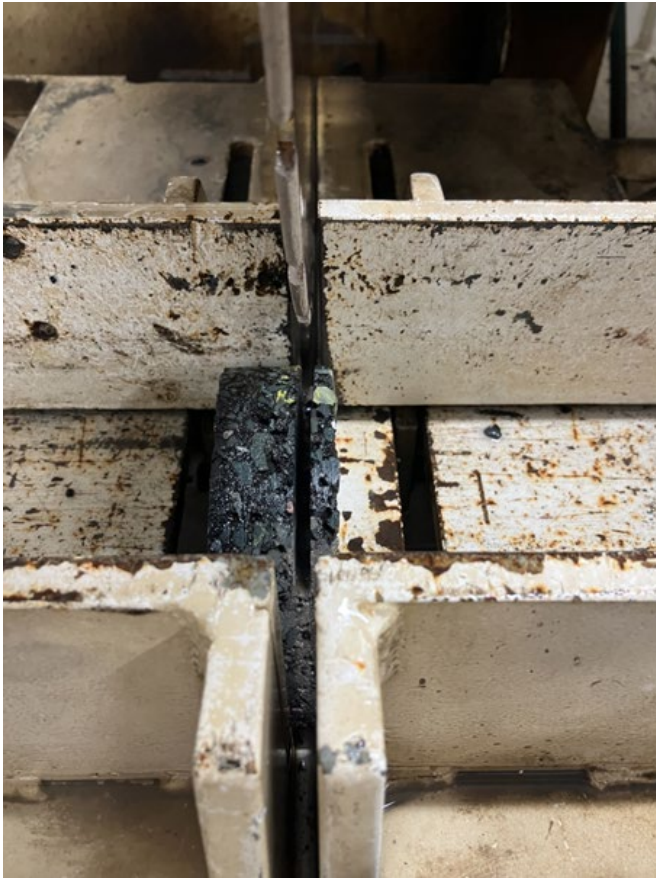
## RESULTS ON CORES

2 recovered binders / sections  
(surface and « bottom »)

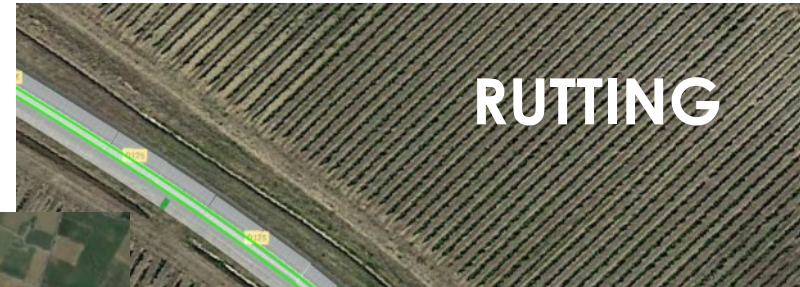
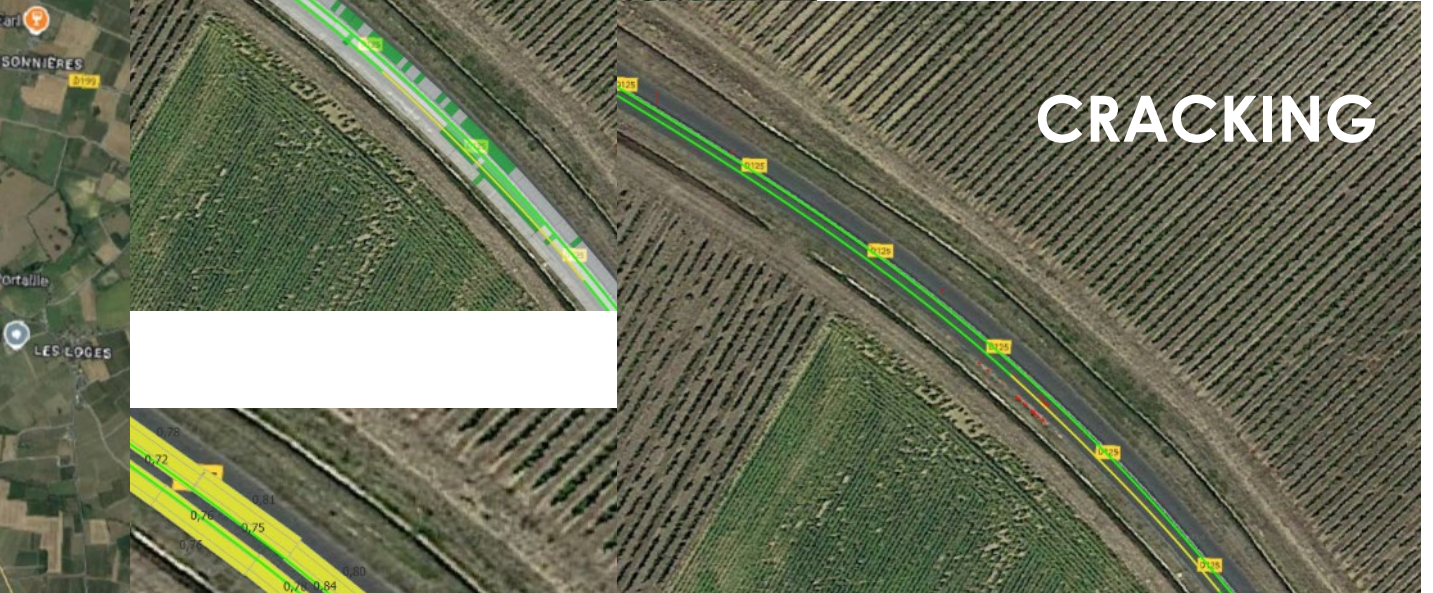
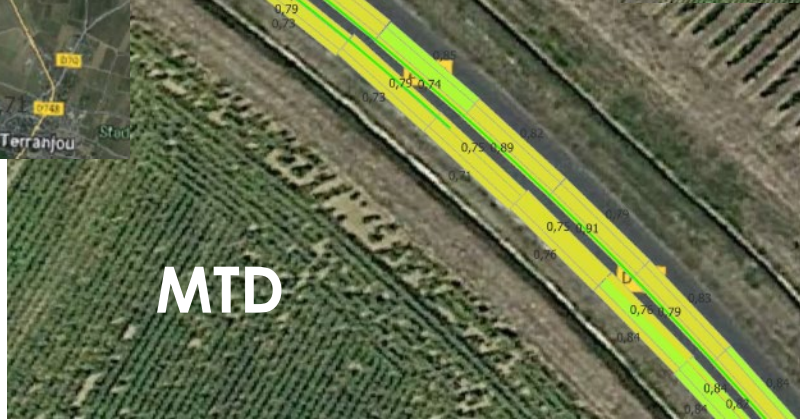
EX RD 125

Detection limits

Possible confusions small ravelling/crack ?

Adaptation on algorithms – Ongoing  
localised damage
