# **WORKSHOP ON BITUMEN EMULSION TECHNOLOGY**

## **Five-Year Field Performance of Cold Recycling in a Cold Climate**

**Jenna Bowers, P.E.**  
**Product development manager**  
**Ingevity**

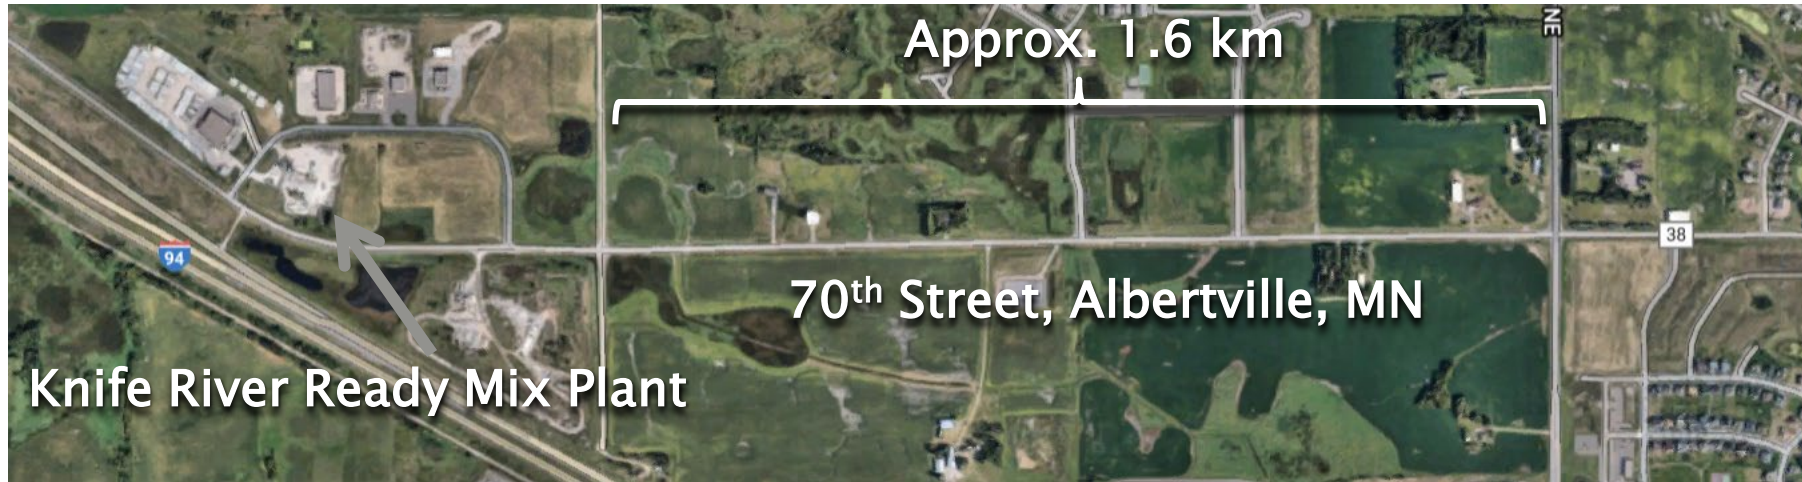
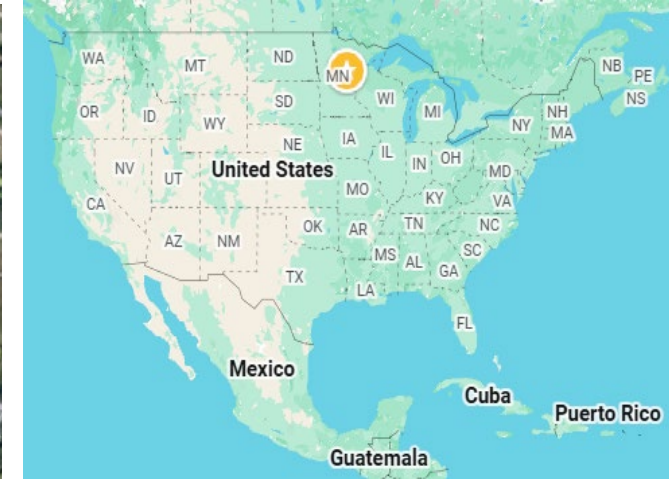
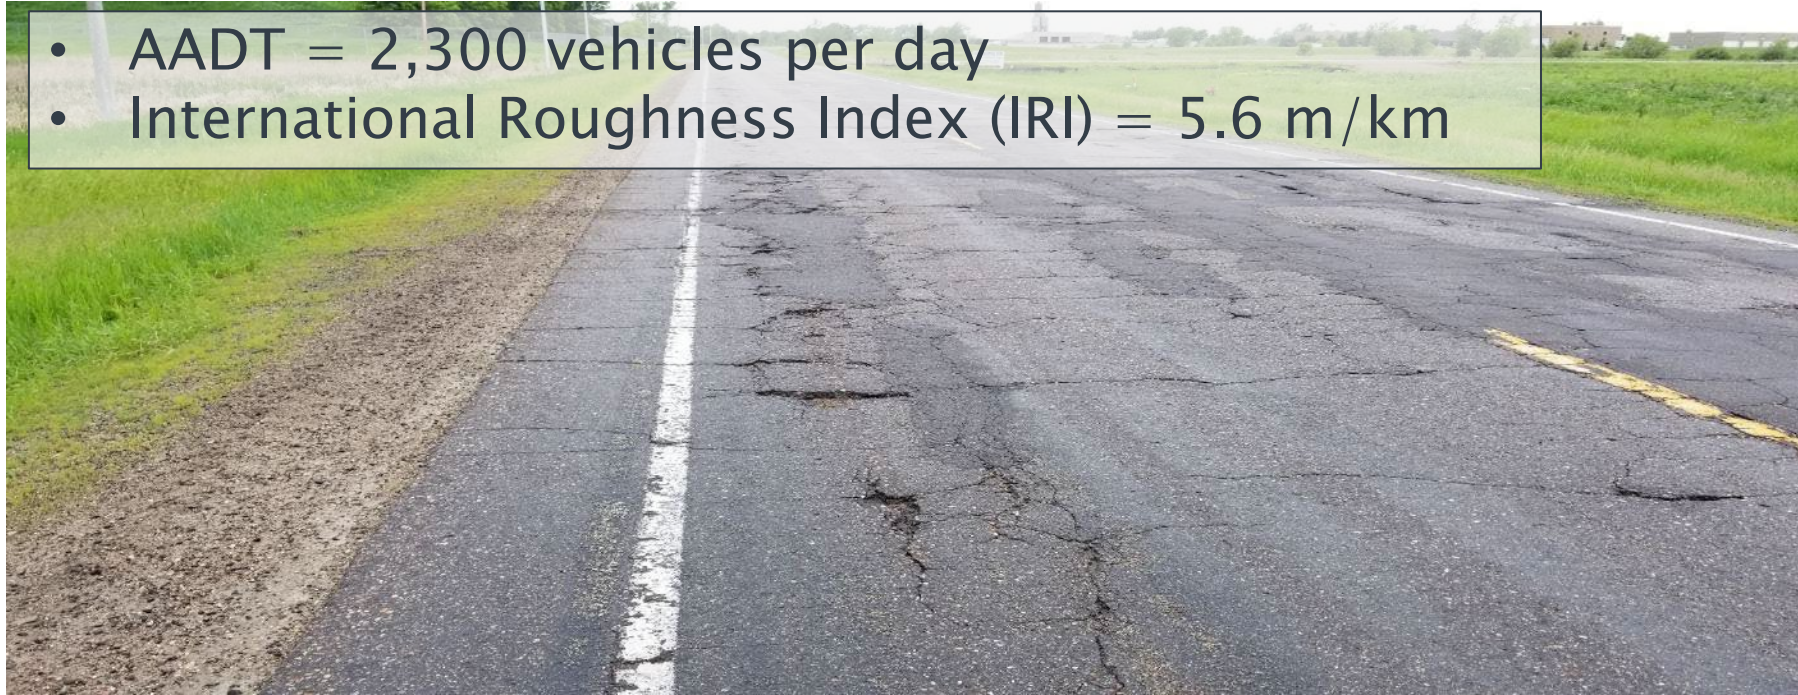
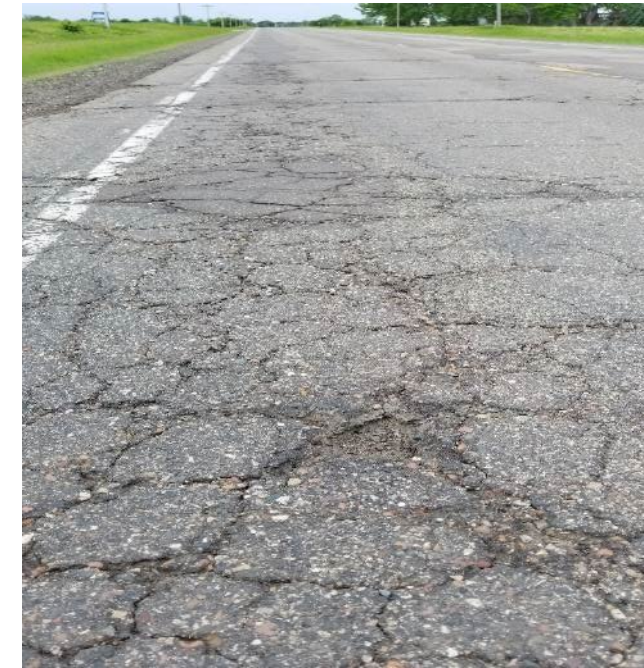
# MnROAD 70<sup>th</sup> Steet Location and Condition

- AADT = 2,300 vehicles per day
- International Roughness Index (IRI) = 5.6 m/km

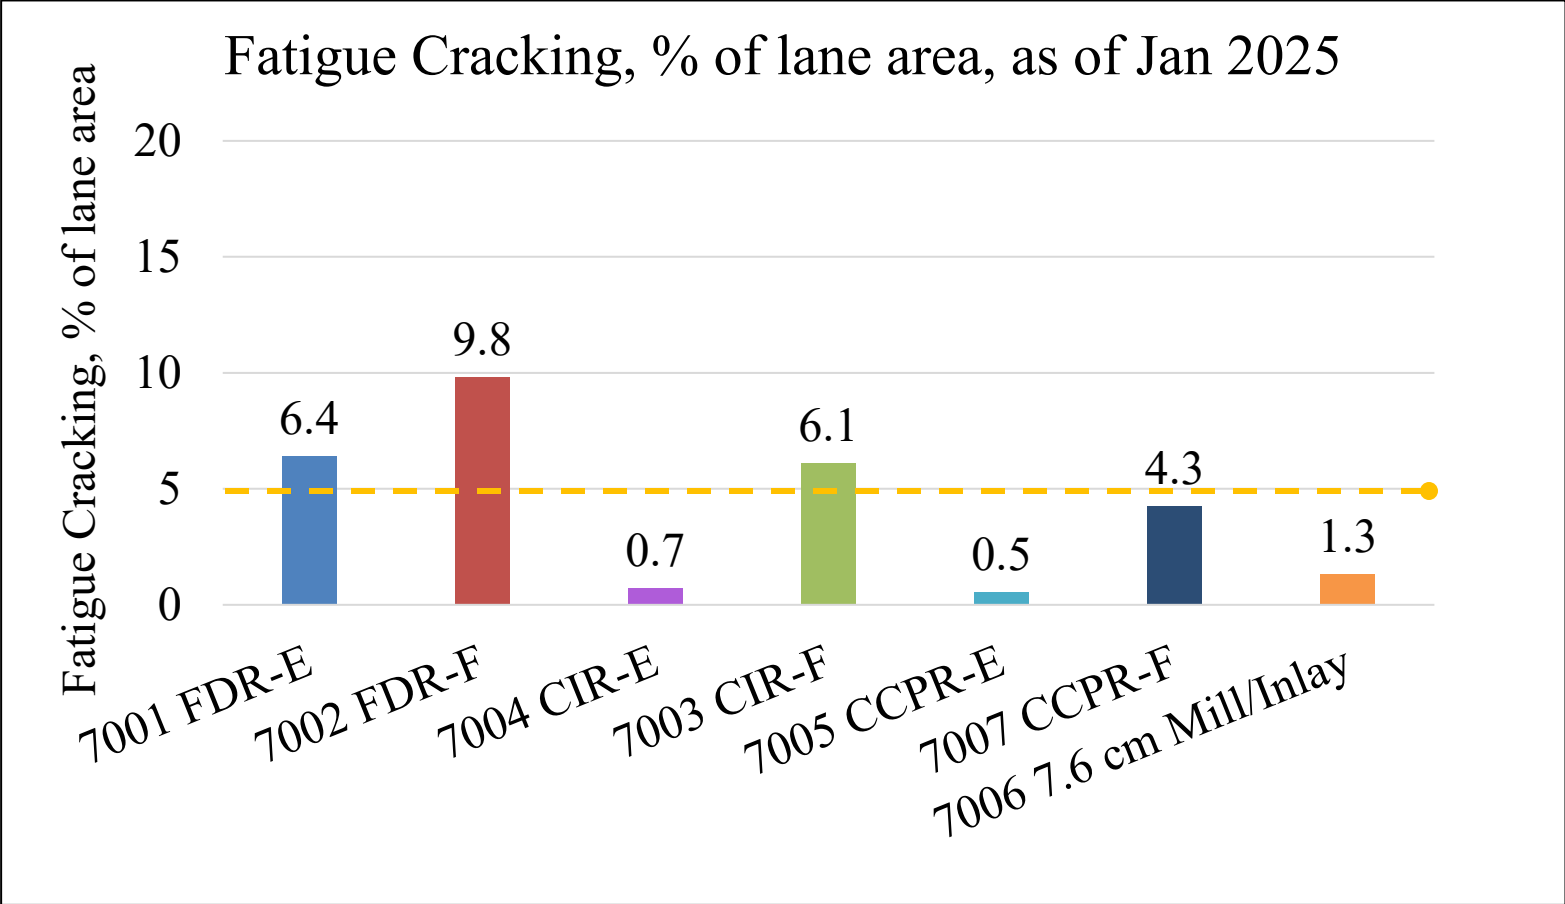
# Results – Fatigue Cracking Performance

Good Condition: < 5% of the lane area exhibits cracking.

Fair Condition: 5% to 20% of the lane area exhibits cracking.

Poor Condition: > 20% of the lane area exhibits cracking.
